1. Report No. NASA CR 134879		2. Government Accession No.		3. Recipient's Catalog No.	
4. Title and Subtitle Continued Development of Abradable Gas Path Seals				5. Report Date November, 1975

6. Performing Organization Code	
7. Author(s) L. T. Shiembob				8. Performing Organization Report No.	
9. Performing Organization Name and Address Pratt & Whitney Aircraft East Hartford, Connecticut 06108				10. Work Unit No.

14. Sponsoring Agency Code	
15. Supplementary Notes Project Manager, Robert C. Bill, NASA Lewis Research Center, Cleveland, Ohio					
16. Abstract The objectives of this program were the continued development of the NiCrAlY Feltmetal and the honeycomb systems for knife edge seal applications in the 1144 to 1366°K (1600 to 2000°F) temperature range, and to initiate abradable seal material evaluation for blade tip seal applications in the 1366 to 1589°K (2000 to 2400°F) temperature range. Larger fiber size, higher density feltmetal showed greatly improved erosion resistance with a slight reduction in abradability compared to the baseline feltmetal. Pack aluminide coating of the honeycomb extended the oxidation resistance and slightly improved the abradability of this mate

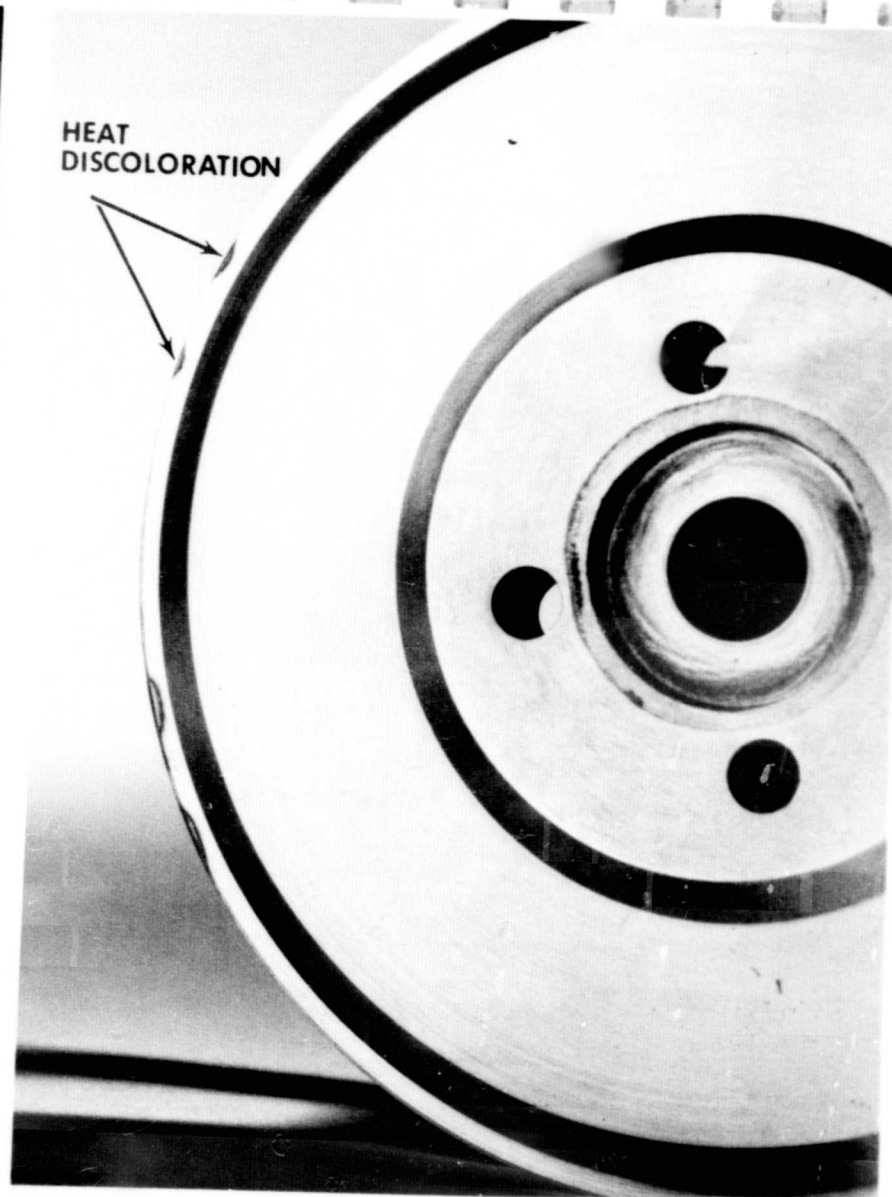
FIGURE 3

TEST #10 PACK-ALUMINIDE COATED HAST-X HONEYCOMB VS. WASPALOY KNIFE EDGE. TEST CONDITIONS: 305 m/s (1000 FT/SEC) SURFACE SPEED, 2.54×10^{-4} m/s (.010 INCH/SEC) INTERACTION RATE AND 1366K (2000°F) TEMPERATURE. NOTE FOUR LOCATIONS OF HEAT DISCOLORATION WITH MAXIMUM PICKUP 3.30×10^{-5} m (.0013 INCH). NO KNIFE EDGE WEAR.

The pack aluminide coated Hastelloy-X honeycomb testing produced no knife edge wear and low torque for all tests. However, some localized heat discoloration and pickup was evident on the outer diameter of all the tested knife edges. In general, the heat distress and pickup was confined to one area of the knife edge, 5-10° in length. One test, #10, conducted at the faster interaction rate of 2.54×10^{-4} m/s (.010 inch/sec) resulted in four distinct distress areas totalling 20 degrees of the knife edge. A photograph of the post test appearance of this knife edge is shown in Figure 3.

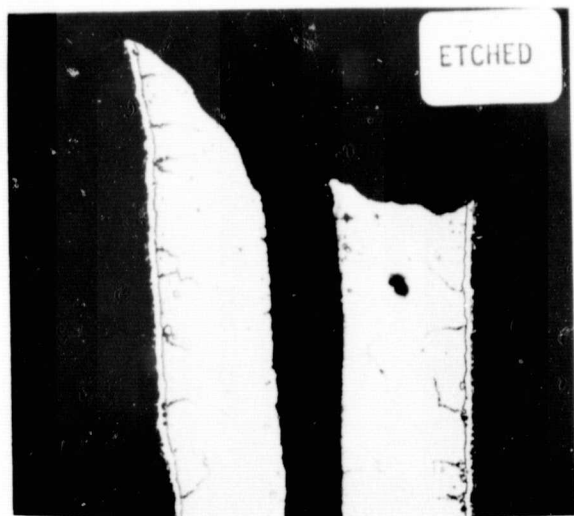
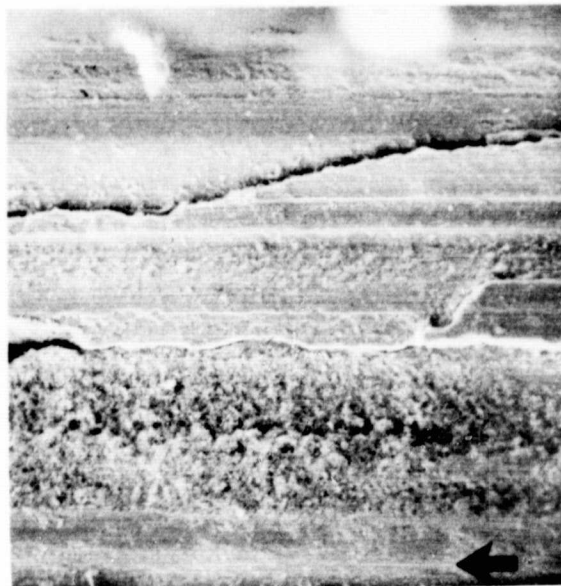
K-16370

33% DENSE NiCrAlY FIBER METAL - TEST NO. 12: (A) MICROSECTION OF RUB GROOVE SHOWING DENSIFICATION AND KNIFE-EDGE MATERIAL DEPOSITS. NON-METALLIC INCLUSIONS ARE PRESENT; (B) SCANNING ELECTRON PHOTOMICROGRAPH OF RUBBED SURFACE. ARROW DENOTES RUB DIRECTION.

A review of all available knife edge test results indicated the possibility of a dependence of rub mechanism, whether pickup or wear, on knife edge surface finish and waviness. A repeat test (#26) of test #12, reference Table XVI, on a fibermetal system using a knife edge machined as "smooth" as possible ($\pm 2.54 \times 10^{-6}$ m (.0001 inch) OD tolerance) at conditions of 305 m/s (1000 ft/sec), 2.54×10^{-5} m/s (.001 inch/sec), and 1366K (2000°F) was conducted.

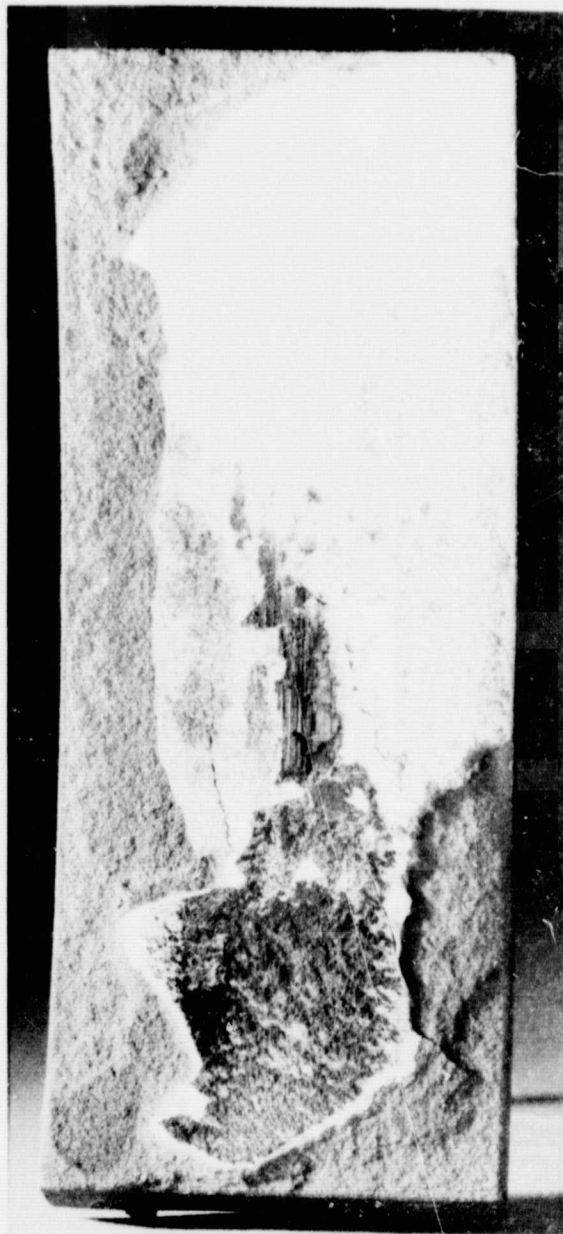
FIGURE 29

TEST #2, CaO STABILIZED ZrO₂/CoCrAlY SEAL MATERIAL VS. B-1900 TEST BLADE. TEST CONDITIONS: 305 m/s (1000 FT/SEC) 2.54×10^{-5} m/s (.001 INCH/SEC) INTERACTION RATE, AND 1589K (2400°F) TEMPERATURE. NOTE - HEAVY SEAL SPALLING AND DELAMINATION OCCURRED DURING POST TEST COOL DOWN.

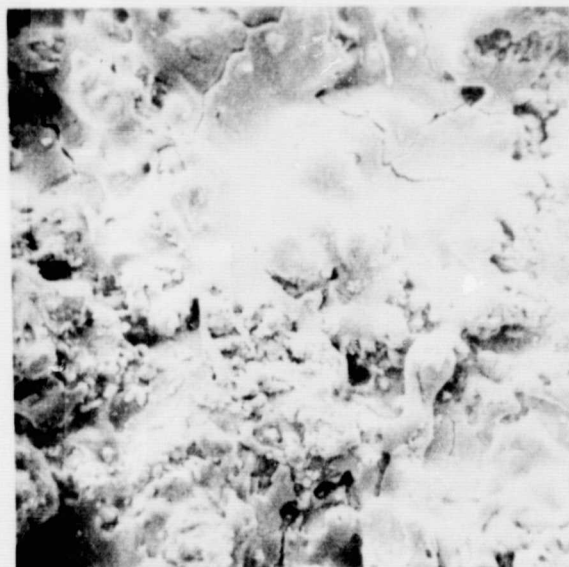
GRADED PLASMA SPRAYED CaO STABILIZED $\text{ZrO}_2/\text{CoCrAlY}$ - TEST NO. 3: (A) MICROSECTION UNDER AND INCLUDING RUBBED SURFACE SHOWING TRANSFERRED AND OXIDIZED BLADE TIP MATERIAL (ARROWS). (B) SCANNING ELECTRON PHOTOMICROGRAPH OF UNRUBBED SURFACE. (C) SCANNING ELECTRON PHOTOMICROGRAPH OF RUB-INDUCED SMEARED BLADE MATERIAL DEPOSIT. ARROW DENOTES RUB DIRECTION. (D) SCANNING ELECTRON PHOTOMICROGRAPH OF RUBBED SURFACE IN AREA OF MINOR BLADE MATERIAL DEPOSIT. ARROW DENOTES RUB DIRECTION.

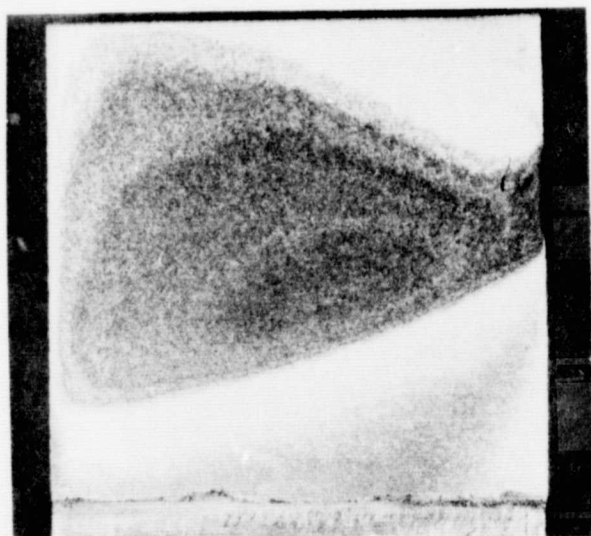
XPN-54834

POST-PARTICULATE EROSION IMPINGEMENT SURFACE OF PLASMA SPRAYED $\text{CeO}_2/\text{NiCoCrAlY}$ SPECIMENS. TEST PARAMETERS: TEST TEMPERATURES INDICATED, 1589K (2400 °F) WITH ABRASIVE CONDUCTED AT 15° REMAINING AT 7° IMPINGEMENT ANGLE, 1200 SECOND TEST DURATION, .35 MACH GAS VELOCITY, 80 GRIT - Al_2O_3 ABRASIVE PARTICLES, AND $7.50 \times 10^{-3} \text{ kg/s}$ (6.0 LBS/HR) MASS FLOW RATE. ARROWS INDICATE PARTICLE FLOW DIRECTION. MAG 2X

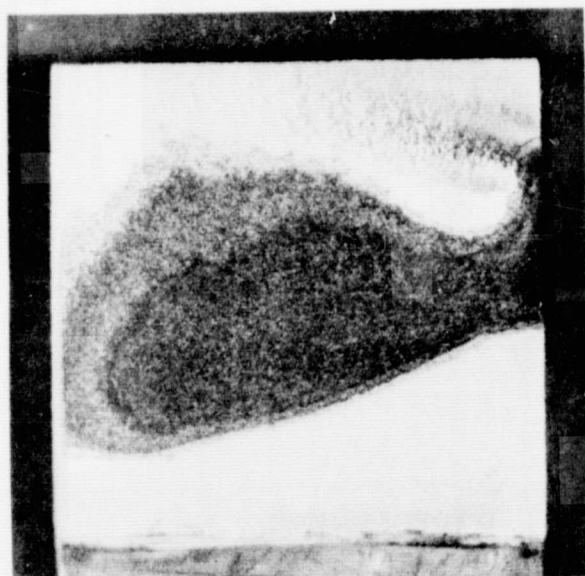
FIGURE 35

POST PARTICULATE EROSION IMPINGEMENT SURFACE OF CaO STABILIZED ZrO₂ TOP COAT, ZrO₂/CoCrAlY INTERMEDIATE LAYER SPECIMENS. TEST PARAMETERS: TEST TEMPERATURES INDICATED, 15° IMPINGEMENT ANGLE, 1200 SECOND TEST DURATION, .35 MACH GAS VELOCITY, 80 GRIT - Al₂O₃ ABRASIVE PARTICLES, AND 7.50×10^{-3} kg/s (6.0 LBS/HR) MASS FLOW RATE. ARROW INDICATED PARTICLE FLOW DIRECTION. MAG 2X

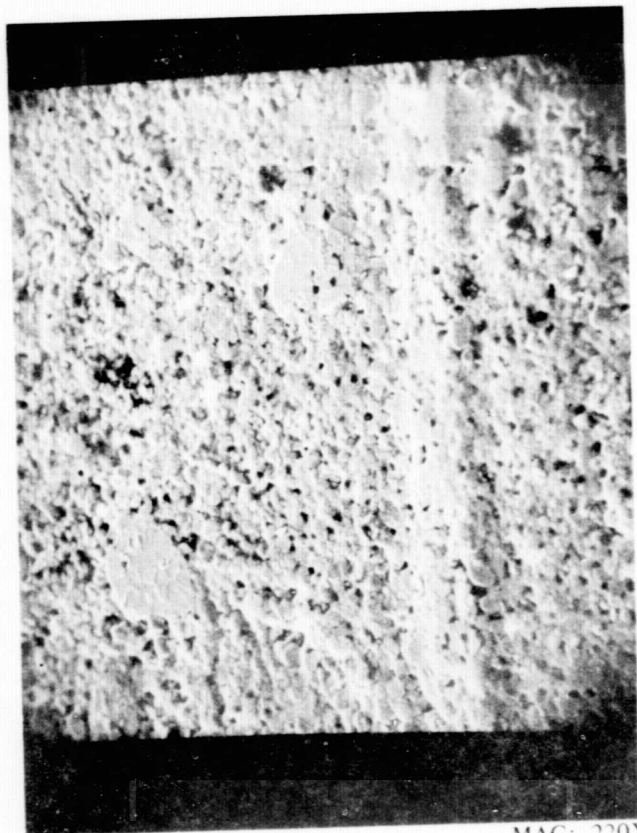
FIGURE 40
RUBBED AND UNRUBBED SURFACES OF SPRAYED CONTINUOUSLY GRADED
 $\text{Y}_2\text{O}_3\text{-ZrO}_2/\text{CoCrAlY}$ SEAL TESTED AT 2400F

SURFACE IN GROOVE
(NOTE SMEARED, FUSED APPEARANCE)

UNRUBBED SURFACE

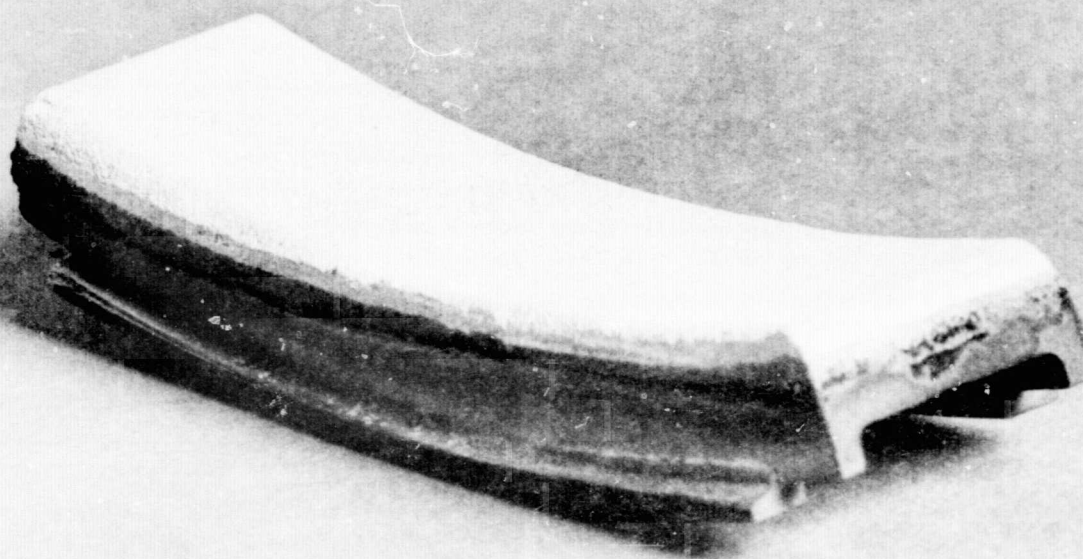
FIGURE E

TYPICAL CONFIGURATION OF CERAMIC SPRAYED RUB
SPECIMEN DEPOSITED ON CURVED METAL SUBSTRATE.
CN-50848
